An experimental model for assessing abrasion and erosion damage of coral concrete under flow conditions

Abstract: Coral concrete is a structural solution for building breakwaters in coastal areas and offshore islands. However, in the marine environment, this structure is often affected by waves and currents carrying coral sand, causing the structure to gradually abrade and erode, affecting the quality of the project. This study builds a laboratory experimental model with five different ages of coral concrete (1, 3, 7, 14, 28 days) to assess the level of abrasion and erosion. The results show that coral concrete has the same compressive strength with repeated loading as regular concrete, but its resistance to abrasion and erosion is worse. 3D scanning results show that concrete samples under 7 days have relatively profound material loss. At 7 and 28 days, coral concrete lost 22.3% and 15.3% of mass due to abrasion and erosion, respectively, compared to regular concrete. Therefore, it is necessary to improve the abrasion and erosion resistance of coral concrete to ensure the durability and longevity of the structure when constructed on offshore islands.

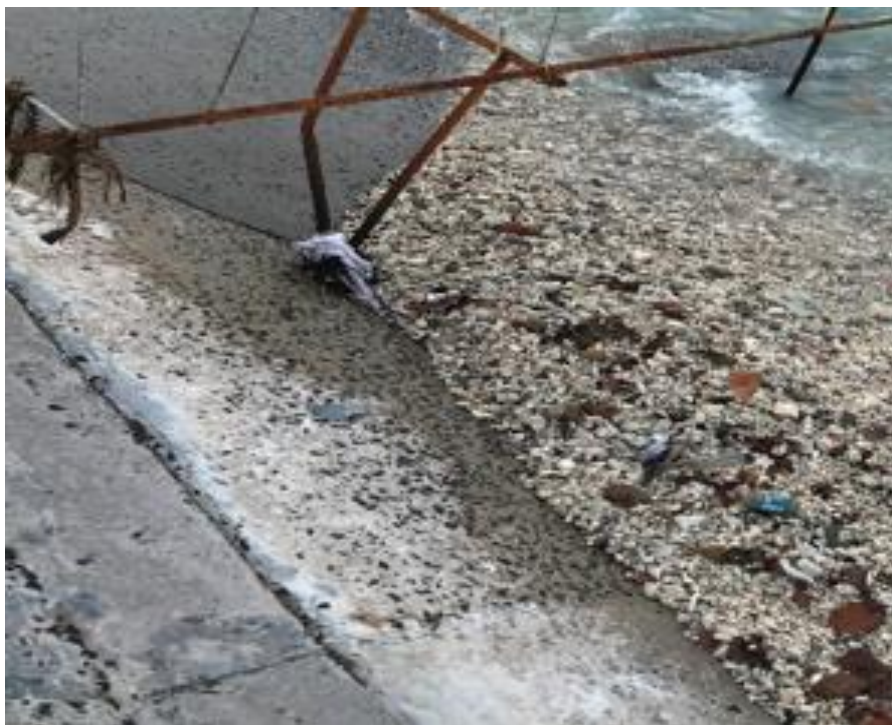
However, a notable point in this construction method is the relatively early dismantling time of the cofferdam. When the concrete of the wave deflector and tray foot structures has just reached the age of about 1 to 3 days - that is, still in the early stages of strength development - the cofferdam has begun to be dismantled. The filling material from the cofferdam is then reused to fill and construct the slope, helping to optimize resources and reduce material transportation costs. However, early dismantling means the concrete structures have not yet reached optimal strength and must be directly exposed to the marine environment. Under the impact of strong sea waves, the wave-absorbing tooth and tray foot structures are at risk of being affected right from the beginning. When the concrete strength is not large enough, the ability to withstand the impact force of waves and currents is limited. In addition, sand particles and suspended materials in seawater can cause abrasion and erosion, reducing the surface quality of concrete over time, as shown in Figure 3.

Figure 3.
The Slope of the Breakwater is Prone to Abrasion and Erosion after Construction.

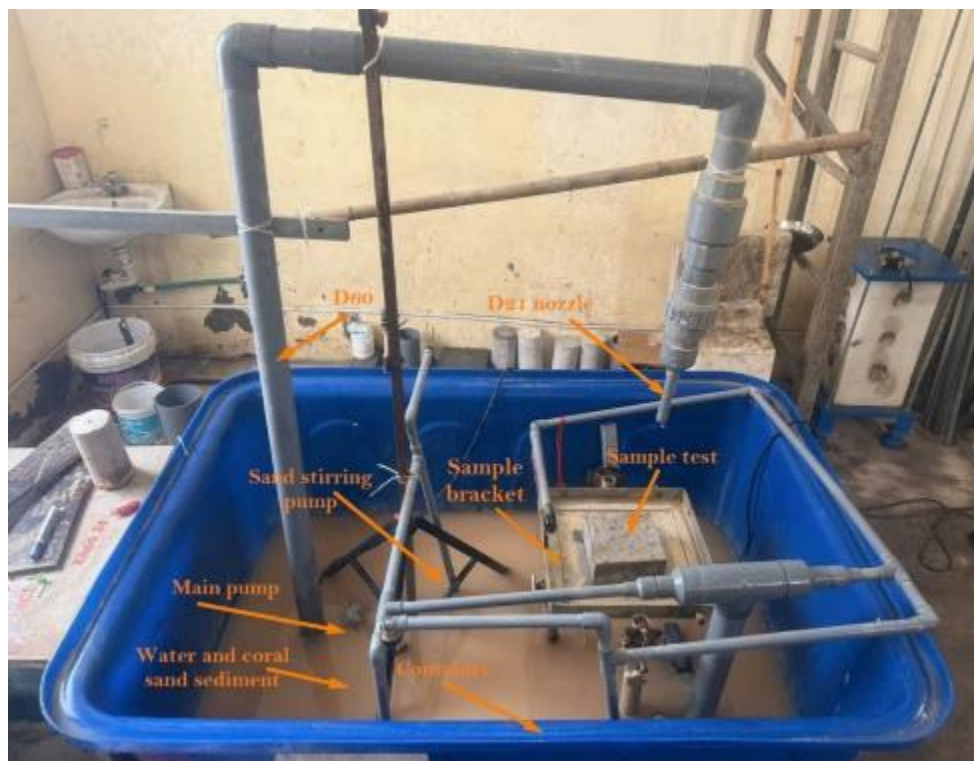
The experimental equipment includes a container with dimensions of 1.5 x 1.0 x 1.0m, a main pump (submersible pump for continuous circulation containing coral sand sediment), and a stand for installing concrete samples. During the experiment, a pump continuously stirs the coral sand in the container to prevent it from settling and ensure even distribution during operation, helping it mix well with water. The bracket for installing concrete samples can adjust the tilt angle and height.

Figure 4.
Homemade Experimental Equipment for Determining Abrasion and Erosion Levels.

To study the damage caused by abrasion and erosion of coral concrete samples when exposed to sediment-containing flow (coral sand), a homemade test set was established based on the research idea of Liu and colleagues [19] as shown in Figure 4. The impact experiments of the flow containing coral sediment aim to simulate the damage process caused by abrasion and erosion of coral concrete

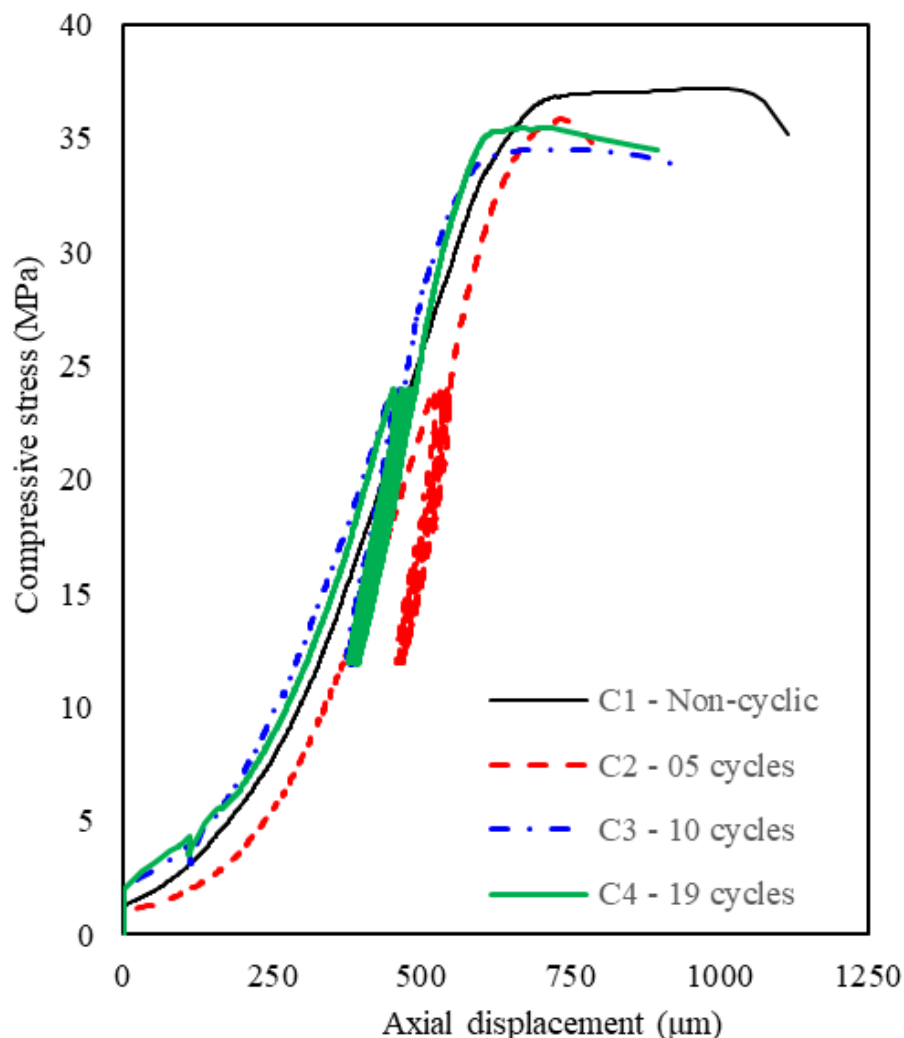
The stress-strain diagram of four coral concrete samples clearly shows the influence of cyclic loading on the material's compressive strength (Figure 6). In sample C1 (not subjected to cyclic loading), the failure stress reaches the highest value of 37.22 MPa. When the number of cycles increases to 5 cycles (sample C2) and 10 cycles (sample C3), the failure stress gradually decreases and drops to 34.53 MPa, corresponding to a decrease of 7.2%. Notably, the failure stress did not decrease linearly when loading cycles increased from 10 to 19 (sample C4). Still, it reached a failure value of 35.48 MPa, corresponding to a decrease of only 4.7%. This shows that the strength of coral concrete does not decrease proportionally to the number of loading cycles, but shows a nonlinear damage mechanism. This mechanism mainly originates from the brittle failure state, gradually changing to plastic failure, and the development of local plastic zones inside the concrete structure when the porosity increases [22]. Under the effect of repeated loading, microcracks at the interface between the aggregate and the cement paste tend to spread, leading to local loss of mechanical bonds, causing the overall strength to decrease. However, after a certain number of cycles, the failure reaches a stable threshold at some points in the structure, causing the rate of decrease in the failure stress to slow, as seen in sample C4. On the other hand, due to the small number of test

Figure 6. Stress-Axial Displacement Relationship of the Coral Concrete Samples with Different Numbers of Loading Cycles.

In summary, within the scope of this study (with a maximum of 19 loading cycles), coral concrete shows a maximum compressive strength reduction of about 7.2%. The lowest strength was observed in sample C3, which reached 34.53 MPa. When converted to the standard cube size of $150 \times 150 \times 150$ mm using a correction factor of 0.95 (by TCVN 3118:2022 [23]) the standard compressive strength is calculated as 32.80 MPa. Based on the mix design shown in Table 1, coral concrete satisfies and exceeds the requirements for grade C30 concrete (strength ≥ 30 MPa). This confirms the feasibility of using coral aggregates to produce structural concrete that meets technical requirements for compressive strength and durability under static and cyclic loading.

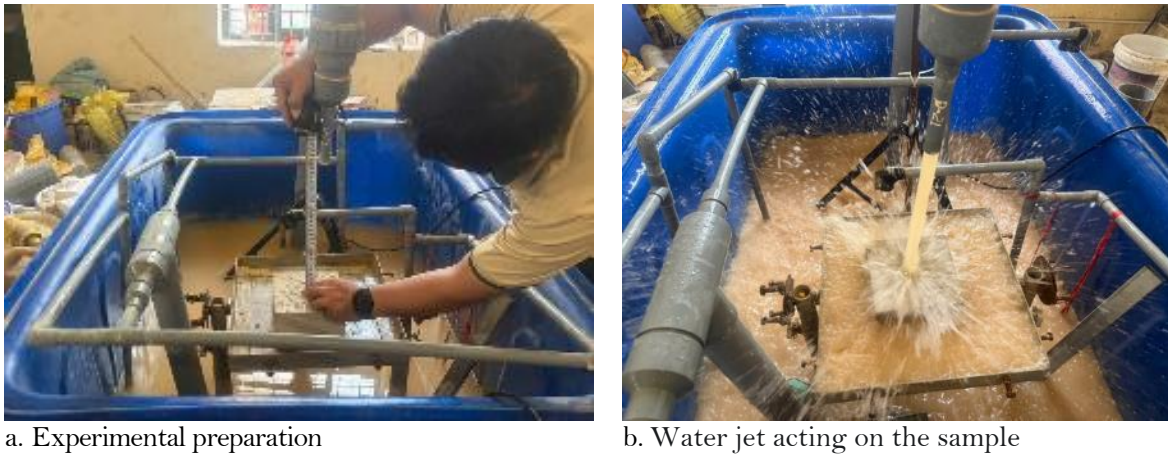
abrasion and erosion of coral concrete at different ages. The concrete samples were fixed on the sample holder, and the sediment-containing flow directly impacted the sample surface, as shown in Figure 7.

a. Experimental preparation

b. Water jet acting on the sample

The Process of Abrasion and Erosion of Coral Concrete Samples.

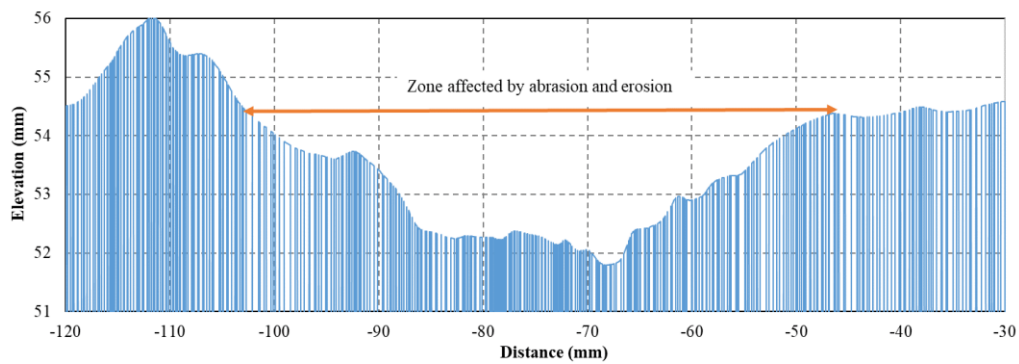
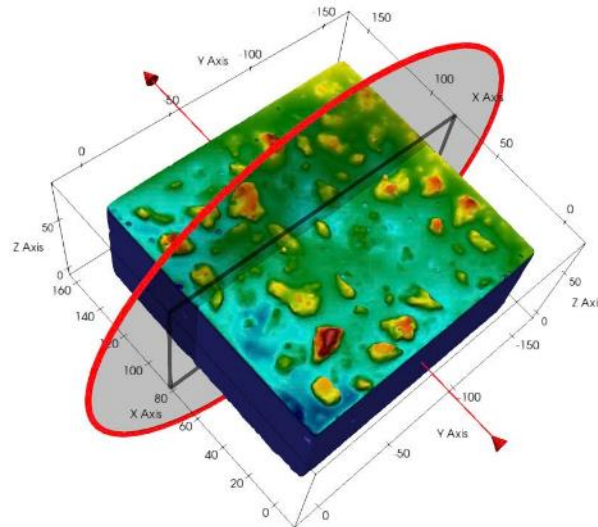
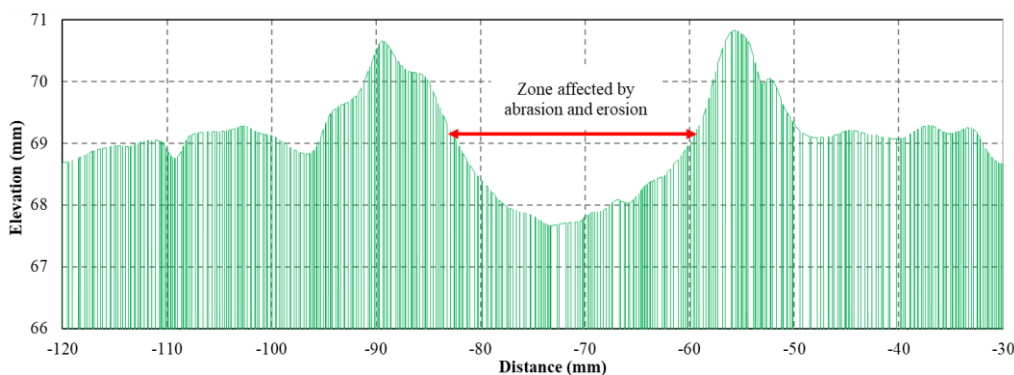
Figure 10.

a. 3D cross-section of sample C3#

b. Cross-section at the center of the area of loss due to abrasion and erosion (sample C3#)

c. 3D cross-section of sample C7#

d. Cross-section at the center of the area of loss due to abrasion and erosion (sample C7#)

CT Scan of the Experimental Sample Using the KSCAN Magic 3D Scanner.

Under the combined impact of continuous flow carrying coral sand particles, the two test samples C3# and C7# showed different levels of surface loss, reflecting a clear difference in erosion resistance. Specifically, according to Figure 10b, sample C3# recorded a loss zone extending from about -102 mm to -47 mm, with the cross-sectional depth decreasing from 54.5 mm to 52 mm, indicating significant material loss. Meanwhile, Figure 10d shows that sample C7# only suffered damage in a narrower range, from -83 mm to -60 mm, with a slight decrease in depth from 69.2 mm to 67.8 mm.

This difference mainly stems from the degree of concrete strength development at different ages. Sample C3# at 3 days of age is still in the early stage of hydration, when the structure is not yet stable, the density is low, and the bond between aggregate particles is not strong enough. This reduces the resistance to mechanical impact and erosion of the flow, leading to a wide range of damage and high material loss. In contrast, sample C7# at 7 days has undergone a longer hydration process, forming a tightly bonded network between aggregate particles and binder. The material structure becomes more stable, significantly improving resistance to abrasion and erosion under the continuous effect of flow. These results show that curing time is decisive in developing coral concrete's mechanical strength and resistance to abrasion and erosion, especially in complex, dynamic and hydraulic environments.

The 3D scanning results after the abrasion and erosion test showed that the coral concrete sample C3# suffered more serious material loss than the C7# sample. This difference reflects the critical role of maintenance work in protecting coral concrete, such as extending the curing time, applying a protective coating, or using additives to improve the mechanical properties of concrete. Enhancing coral concrete's abrasion and erosion resistance is necessary for application in marine environments and offshore island areas.
